### **CRAZING CRACKS (ALSO KNOWN AS EXPANSION / CONTRACTION CRACKS)**

#### **CERAMICS 101**

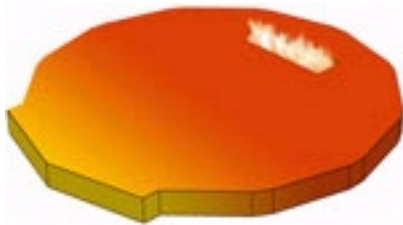
**WOOD STONE**

Some cracking is a natural part of all ceramic materials that come in contact with elevated temperatures, especially with daily heating and cooling. In a Wood Stone oven, the cracking that you may see in the floor of the oven is something that we expect to see eventually in all of our ovens. This is nothing to be concerned about!

Moreover, in our older ovens we allowed for some of the shrinkage / expansion cracks by placing 3 expansion joints directly into the floor casting, and by casting joints into the dome. In the newest of our ovens, we have removed these expansion joints in the floor casting because we found that the oven would make a smaller joint than we could in our casting process.

In fact, it has been our experience that because of the large amount of surface area still in direct contact there is no appreciable difference in cooking performance.

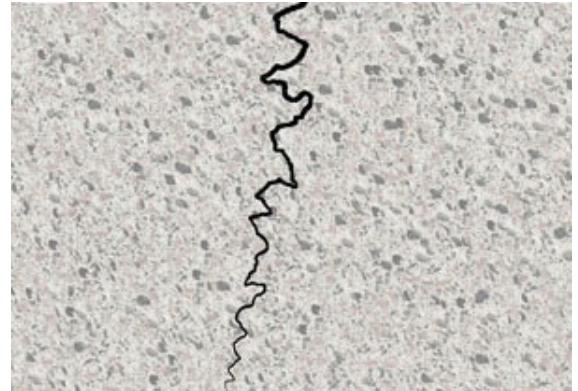
One thing that you can't see about the crack is the actual path that it follows and its relative size inside the floor and dome. Because these are coarse grained ceramic materials, this crack does not extend through the ceramic as if it was cut by a saw.

It meanders back and forth through the 4" thickness and decreases in size from the hot face to the insulated outside surface.

The roughness of this crack actually holds the cracked surfaces rigid, and prevents it from coming apart and shifting. This is the key. All floors and domes crack -- Ours is designed not to shift afterwards causing cooking problems.

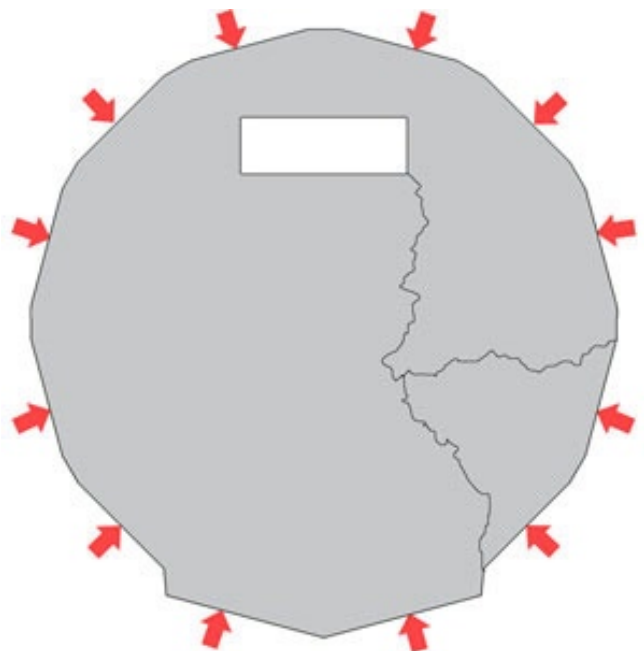
The other thing that you can't see looking at the inside of the oven is how it is supported. There is a metal exoskeleton that connects the floor of the oven to the dome and that also surrounds the exterior surface of the floor and dome.

The exoskeleton provides support and direction for the ceramics, and further ensures that no shifting can occur. In the image at the right, the containing force of this support is indicated by the Red Arrows.

If any crack affects production in any way, just give us a call. We take the service commitment to our customers very seriously. We will do our part to provide you with many years of trouble free production. We hope that this allays any concerns you may have. If you have any questions please call us to discuss them.
